# Drop Impact Reliability Testing for Lead-Free and Leaded Soldered IC Packages

Desmond Y.R. Chong\*, Kellin Ng, Jane Y.N. Tan, Patrick T.H. Low  
United Test & Assembly Center Ltd (UTAC)  
Packaging Analysis & Design Center  
5 Serangoon North Ave 5, Singapore, 554916  
\*Email: desmond\_chong@utac.com.sg Tel: 65-65511348

## Abstract

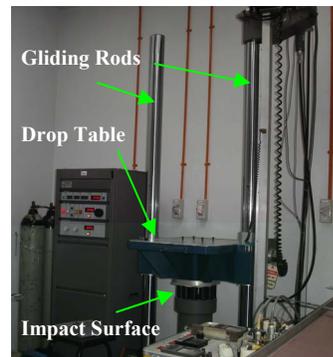
Fig 1. Lansmont Model 65/81 Drop Impact Tester.

The Lansmont Model 65/81 drop impact tester (as seen Fig. 1) is used to carry out the board level drop impact test. The samples used in this experiment are 35x35mm PBGA (312 balls), 28x28mm PQFP (208 leads) and 7x7mm VQFN (48L) packages. All units are daisy chained for the purpose of interconnection failure monitoring. These packages assembled on a 150x200mm test board (Fig. 2) were clamped onto an aluminum fixture that is mounted onto the platform of the guided drop impact machine. The solder compositions used in the test are: lead based of 36Pb-62Sn-2Ag for PBGA packages and 15Pb-85Sn for the PQFP/VQFN plating, lead-free of Sn-4Ag-0.5Cu (also known as SAC) for PBGA packages and matte pure tin for the PQFP/VQFN plating. The packages are mounted onto

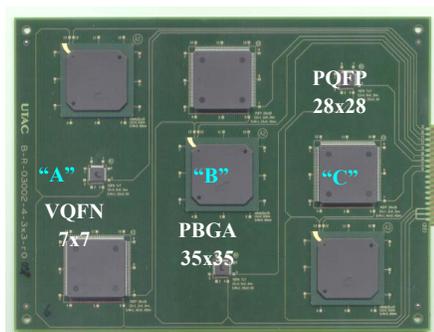
Fig 2. 150x200mm PCB with Drop Test IC Packages.
